**Substation Civils Re-Opener
Basic Project Investment Paper
Willesden 275kV – Switchhouse Roof Repair**

Author	Steve Barnett	Date Started	13/06/2022
Reference Number	2014-073

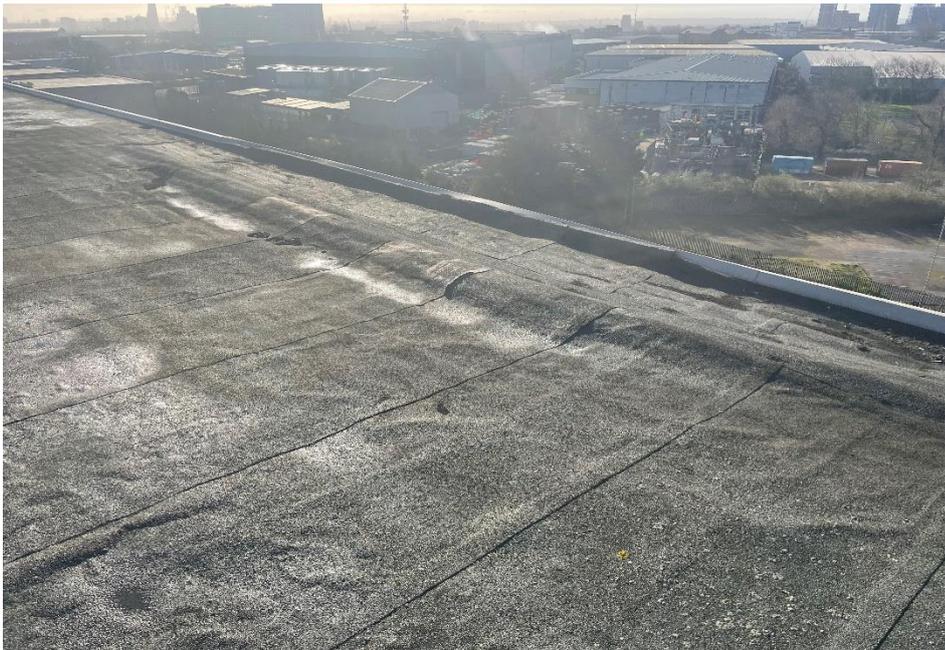
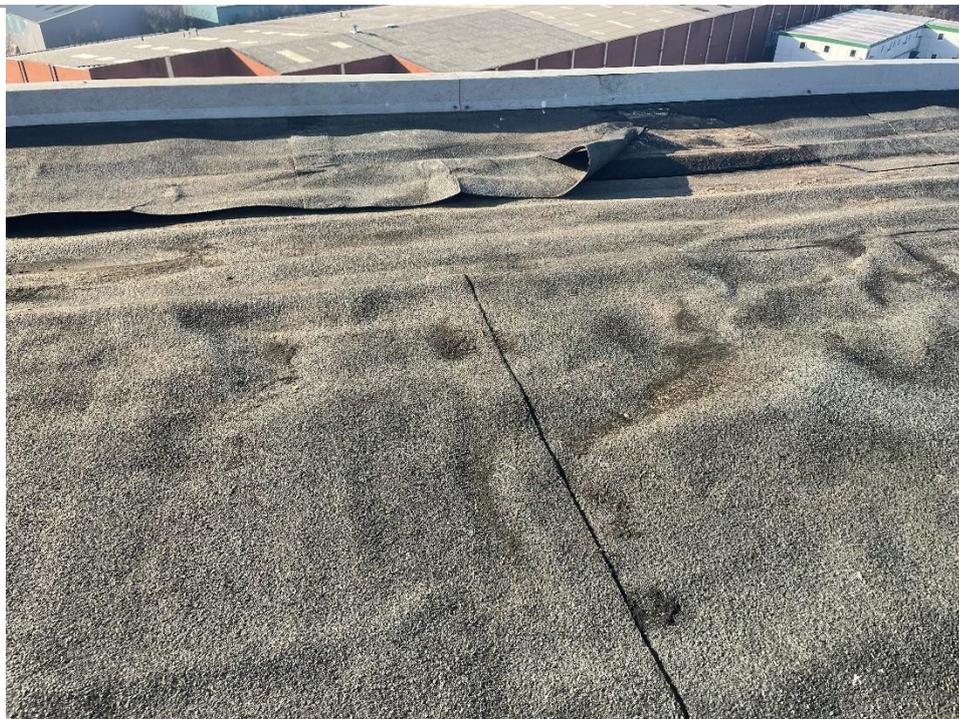
Project Overview	The Switch-House roof at Willesden 275kV substation is leaking, allowing water ingress to the inside of the building. The existing roof requires stripping back and removal of corrugated roof sheeting that is damaged or corroded before being replaced. A new decking and ply membrane should be applied to the roof.
Plant Status Link:	2014-073
Scope Diagram/Photographs
