Re-opener Report

Bespoke: Tower Steelwork and Foundations
(NGET) – ET Special Condition 3.33

Date: 27 July 2022

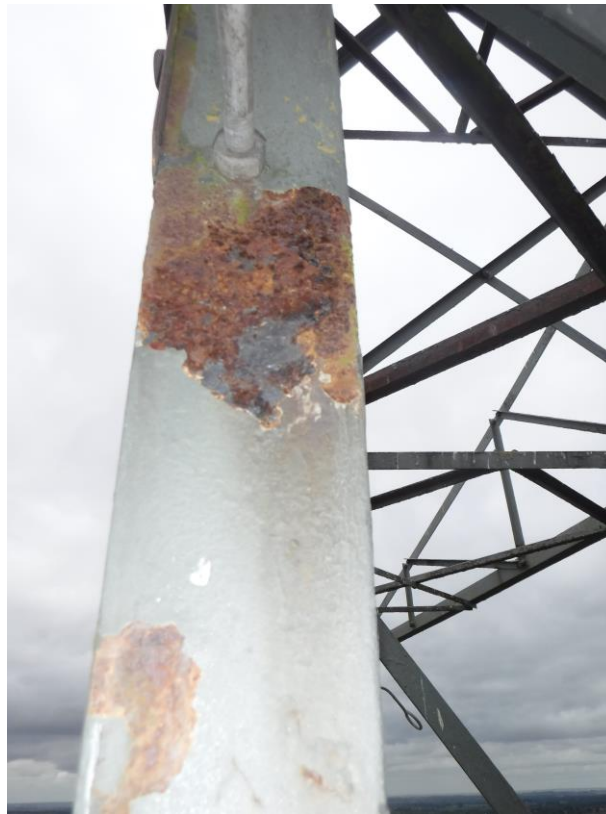
Figure 6.1: Typical grade 5 rust patch on Leg Bars (ZL061 – photo DSCF9174)

Photographs are contained on the Steelwork and Foundation Re-Opener SharePoint site, and a link is provided in Annex 14.1, below is figure 6.1 shows a typical small grade 5 rust patch on a leg bar.

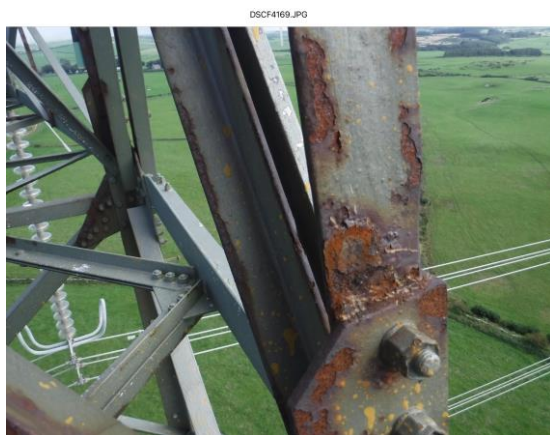
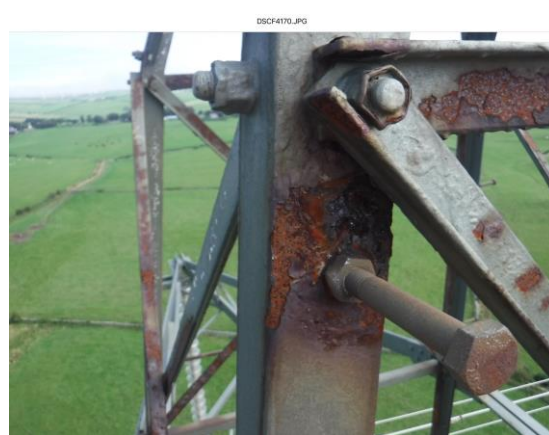
Figure 6.5: Typical photograph examples (4ZA021)

Overview of tower 4ZA021		59.2M					
Inspected By Engineer							
ID Plate photo taken 23/08/2021 11:08:31							
Photo Folder C:\jptowerContracts\SdcDataEast\TowerData\4ZA\Photos\4ZA021\							
Mark	Face	Ht	Gr	UT	Status	Comment	Photos
6D438	CB	6.1	6			Slightly Bent	DSCF4168
6D91	DC	56.9	5	5.8	Critical		DSCF4169
6D92	BA	56.9	5	5.9	Critical		DSCF4170
6D285	AD	56.3	6			Condition	DSCF4171
6D132	CB	12.2	6			Hole	DSCF4173

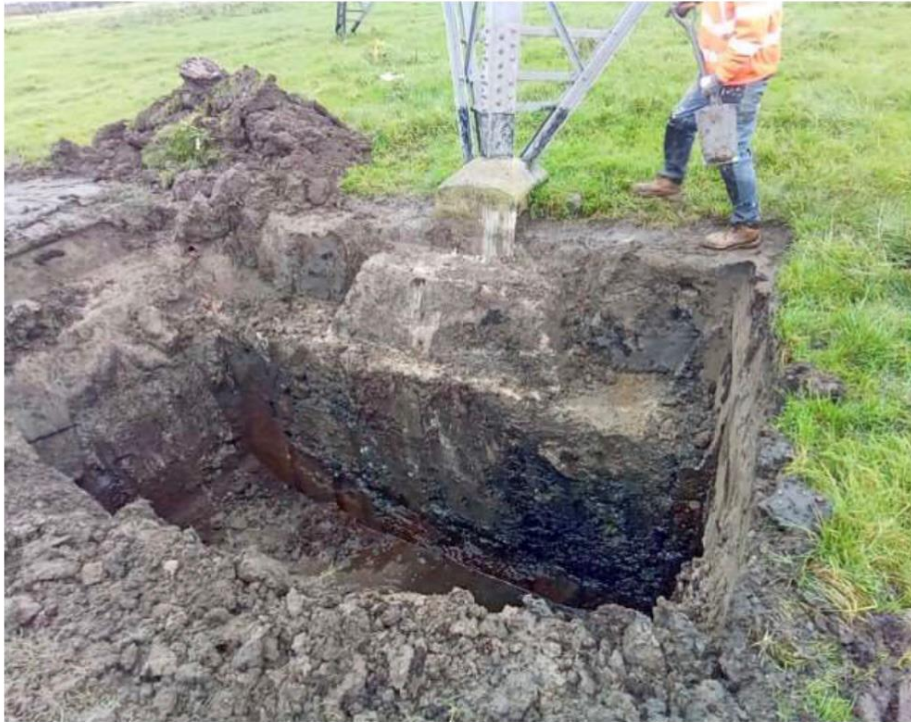
Figure 6.8: Extract from EJR for 4ZE015 showing honey-combed concrete
