nationalgrid					
Scheme: SEA LINK					
Document Title: Marine archaeological study area					
Creator: KF	Date: 12/05/2023	Checker: VL	Date: 12/05/2023	Approver: EM	Date: 12/05/2023
Document Ref: FIGURE 4.7.A.1	Scale: 1:200,000	Format: A3	Sheets: 1	Rev: 0

nationalgrid					
Scheme: SEA LINK					
Document Title: Marine archaeological study area					
Creator: KF	Date: 18/04/2023	Checker: VL	Date: 18/04/2023	Approver: EM	Date: 18/04/2023
Document Ref: FIGURE 4.7.A.3A	Scale: 1:50,000	Format: A3	Sheets: 1	Rev: 0

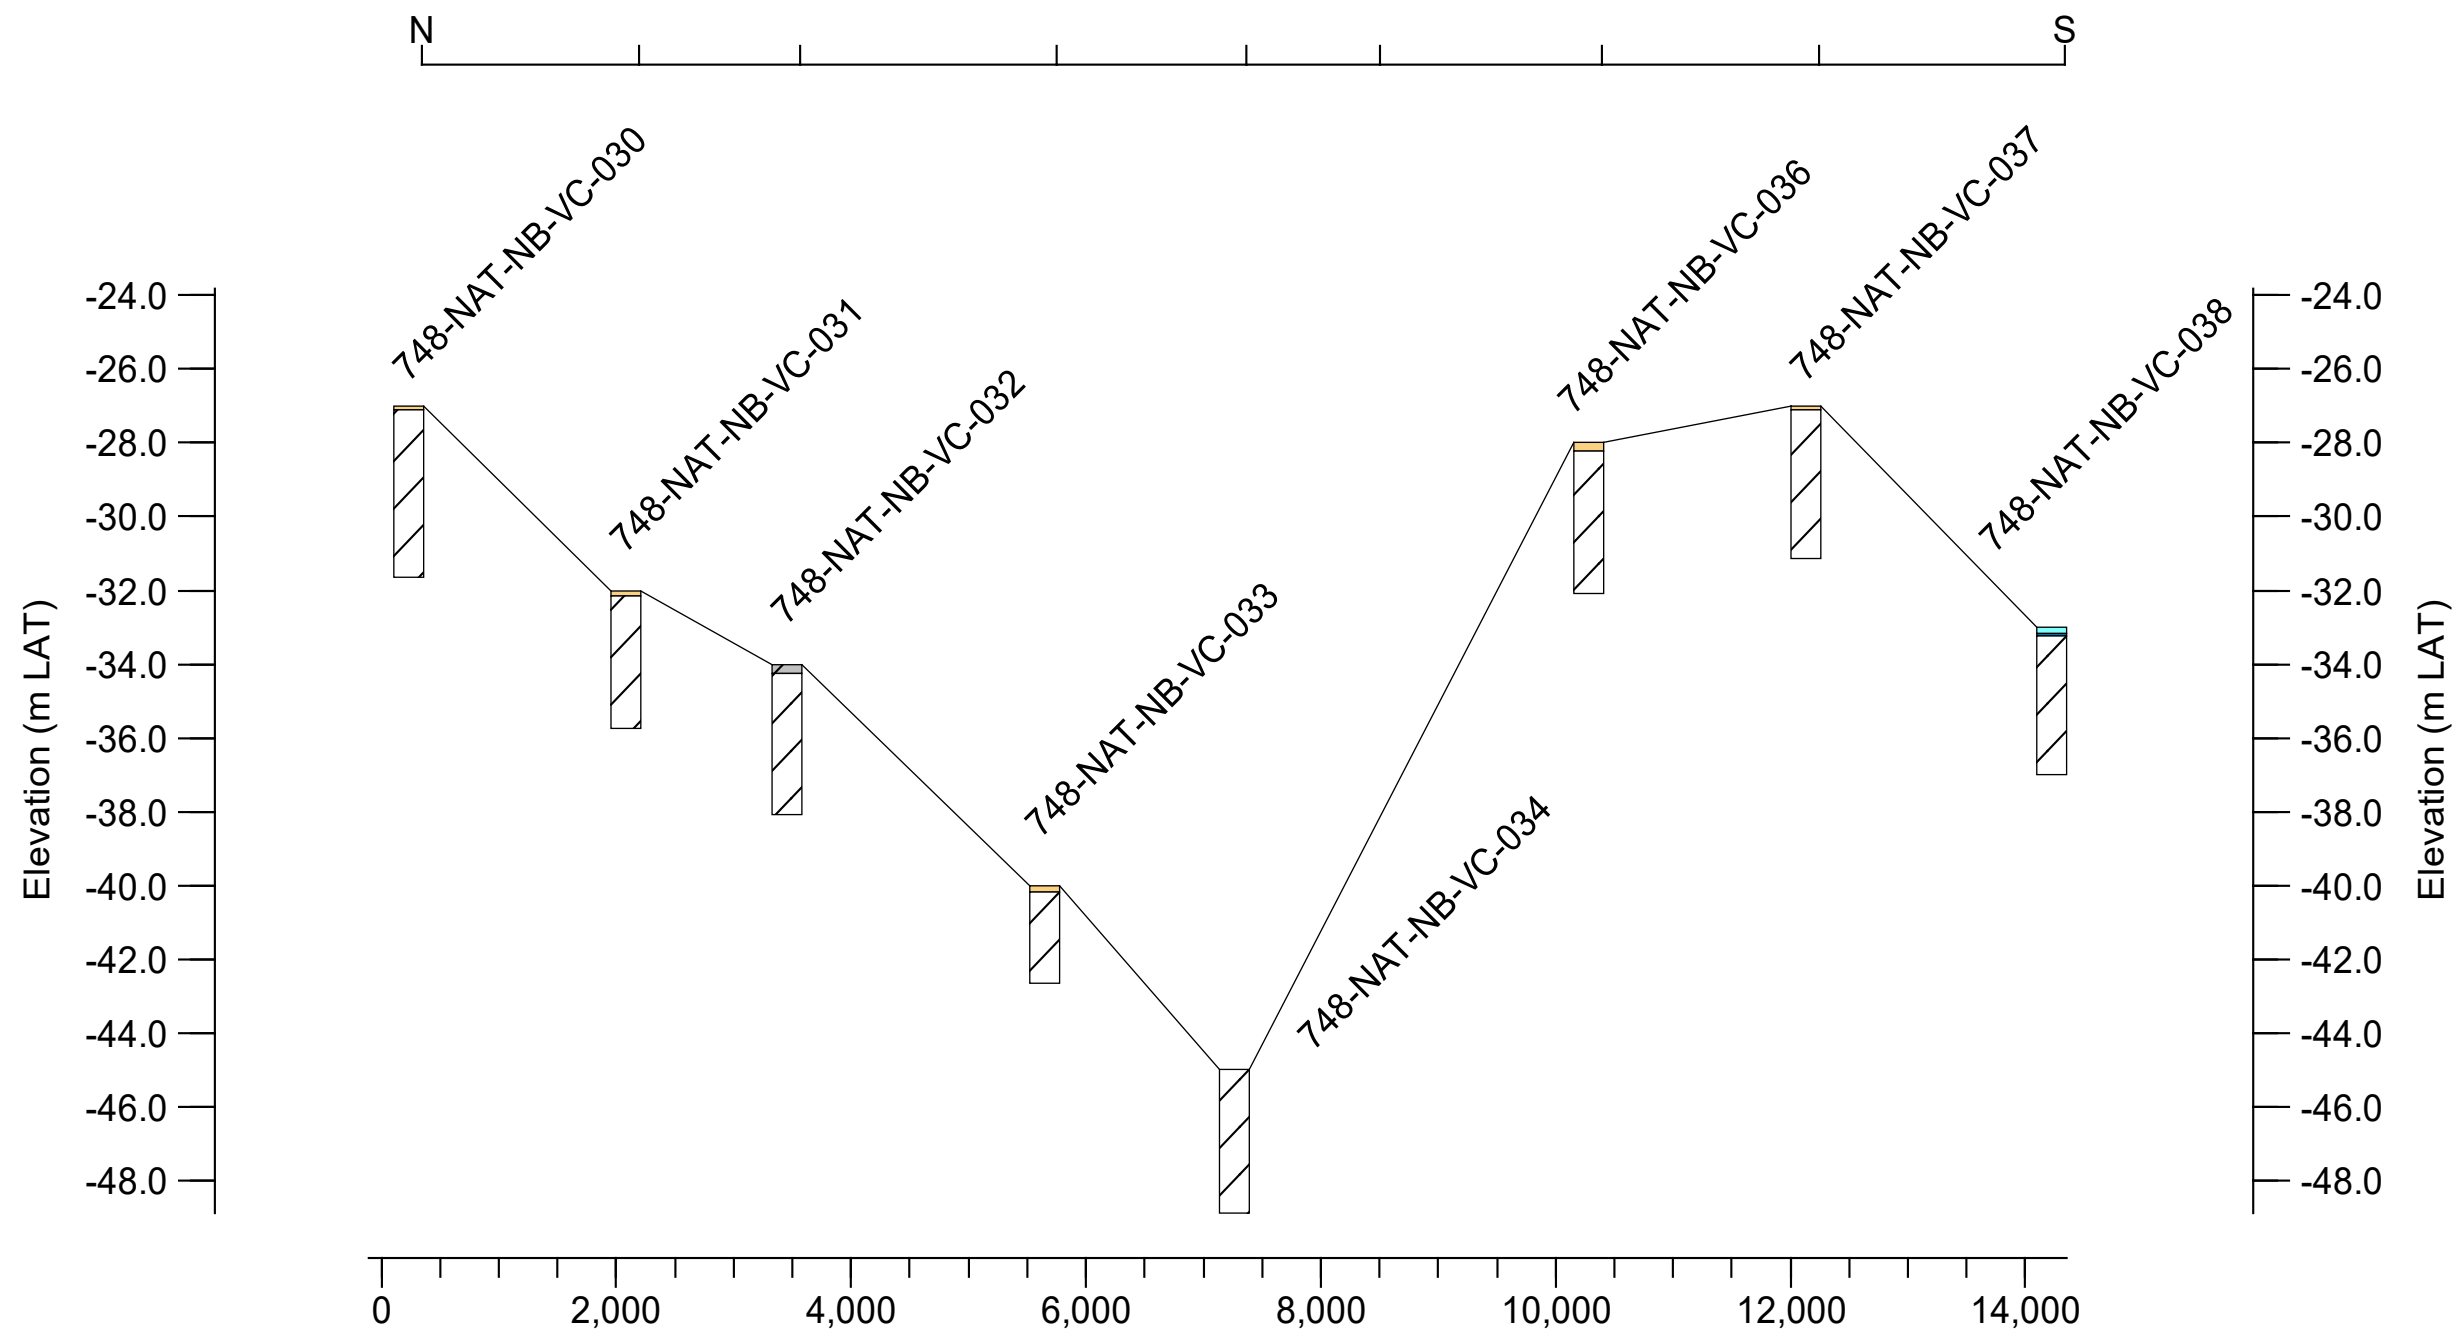
Stratigraphy	
	Seabed sediments
	Alluvium - fine grained organic
	Peat
	Alluvium - fine grained minerogenic
	Shallow marine to coastal
	Oxidised shallow marine sand
	Non-marine sand
	Fluvial gravel
	Reworked/weathered bedrock
	Bedrock

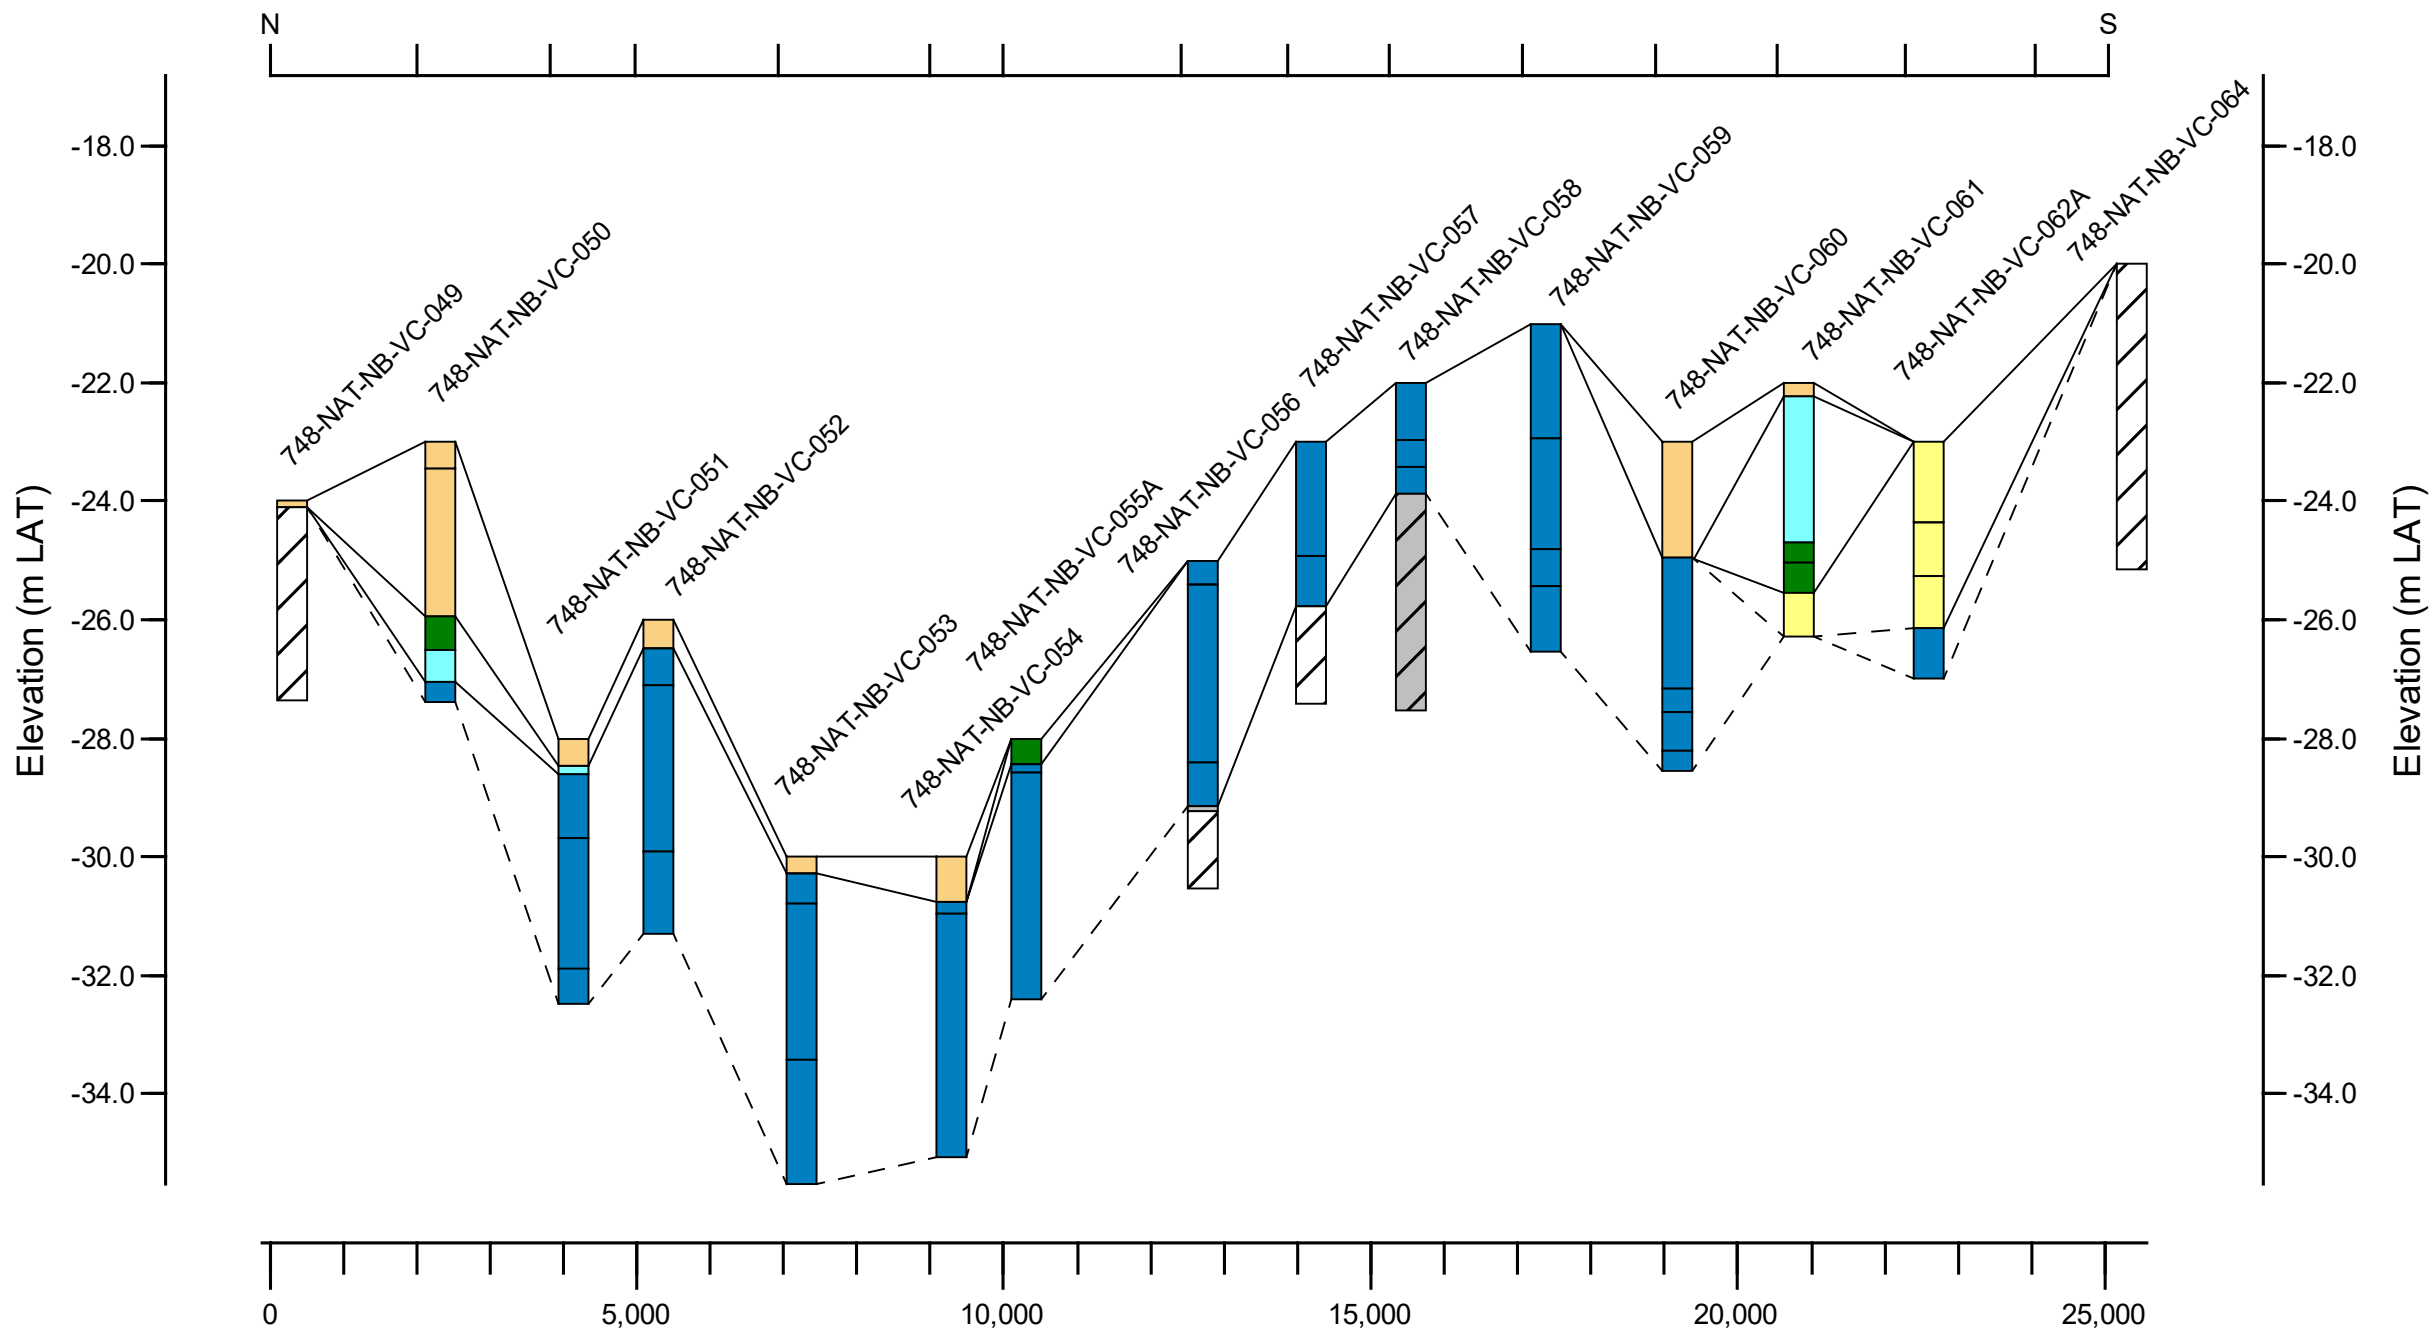
Stratigraphy	
	Seabed sediments
	Alluvium - fine grained organic
	Peat
	Alluvium - fine grained minerogenic
	Shallow marine to coastal
	Oxidised shallow marine sand
	Non-marine sand
	Fluvial gravel
	Reworked/weathered bedrock
	Bedrock
