Appendix 10C

Unexploded Ordnance Reports

Note: These reports relate to the Overton and Monk Fryston substation sites only.

PRELIMINARY UNEXPLODED ORDNANCE (UXO) THREAT ASSESSMENT

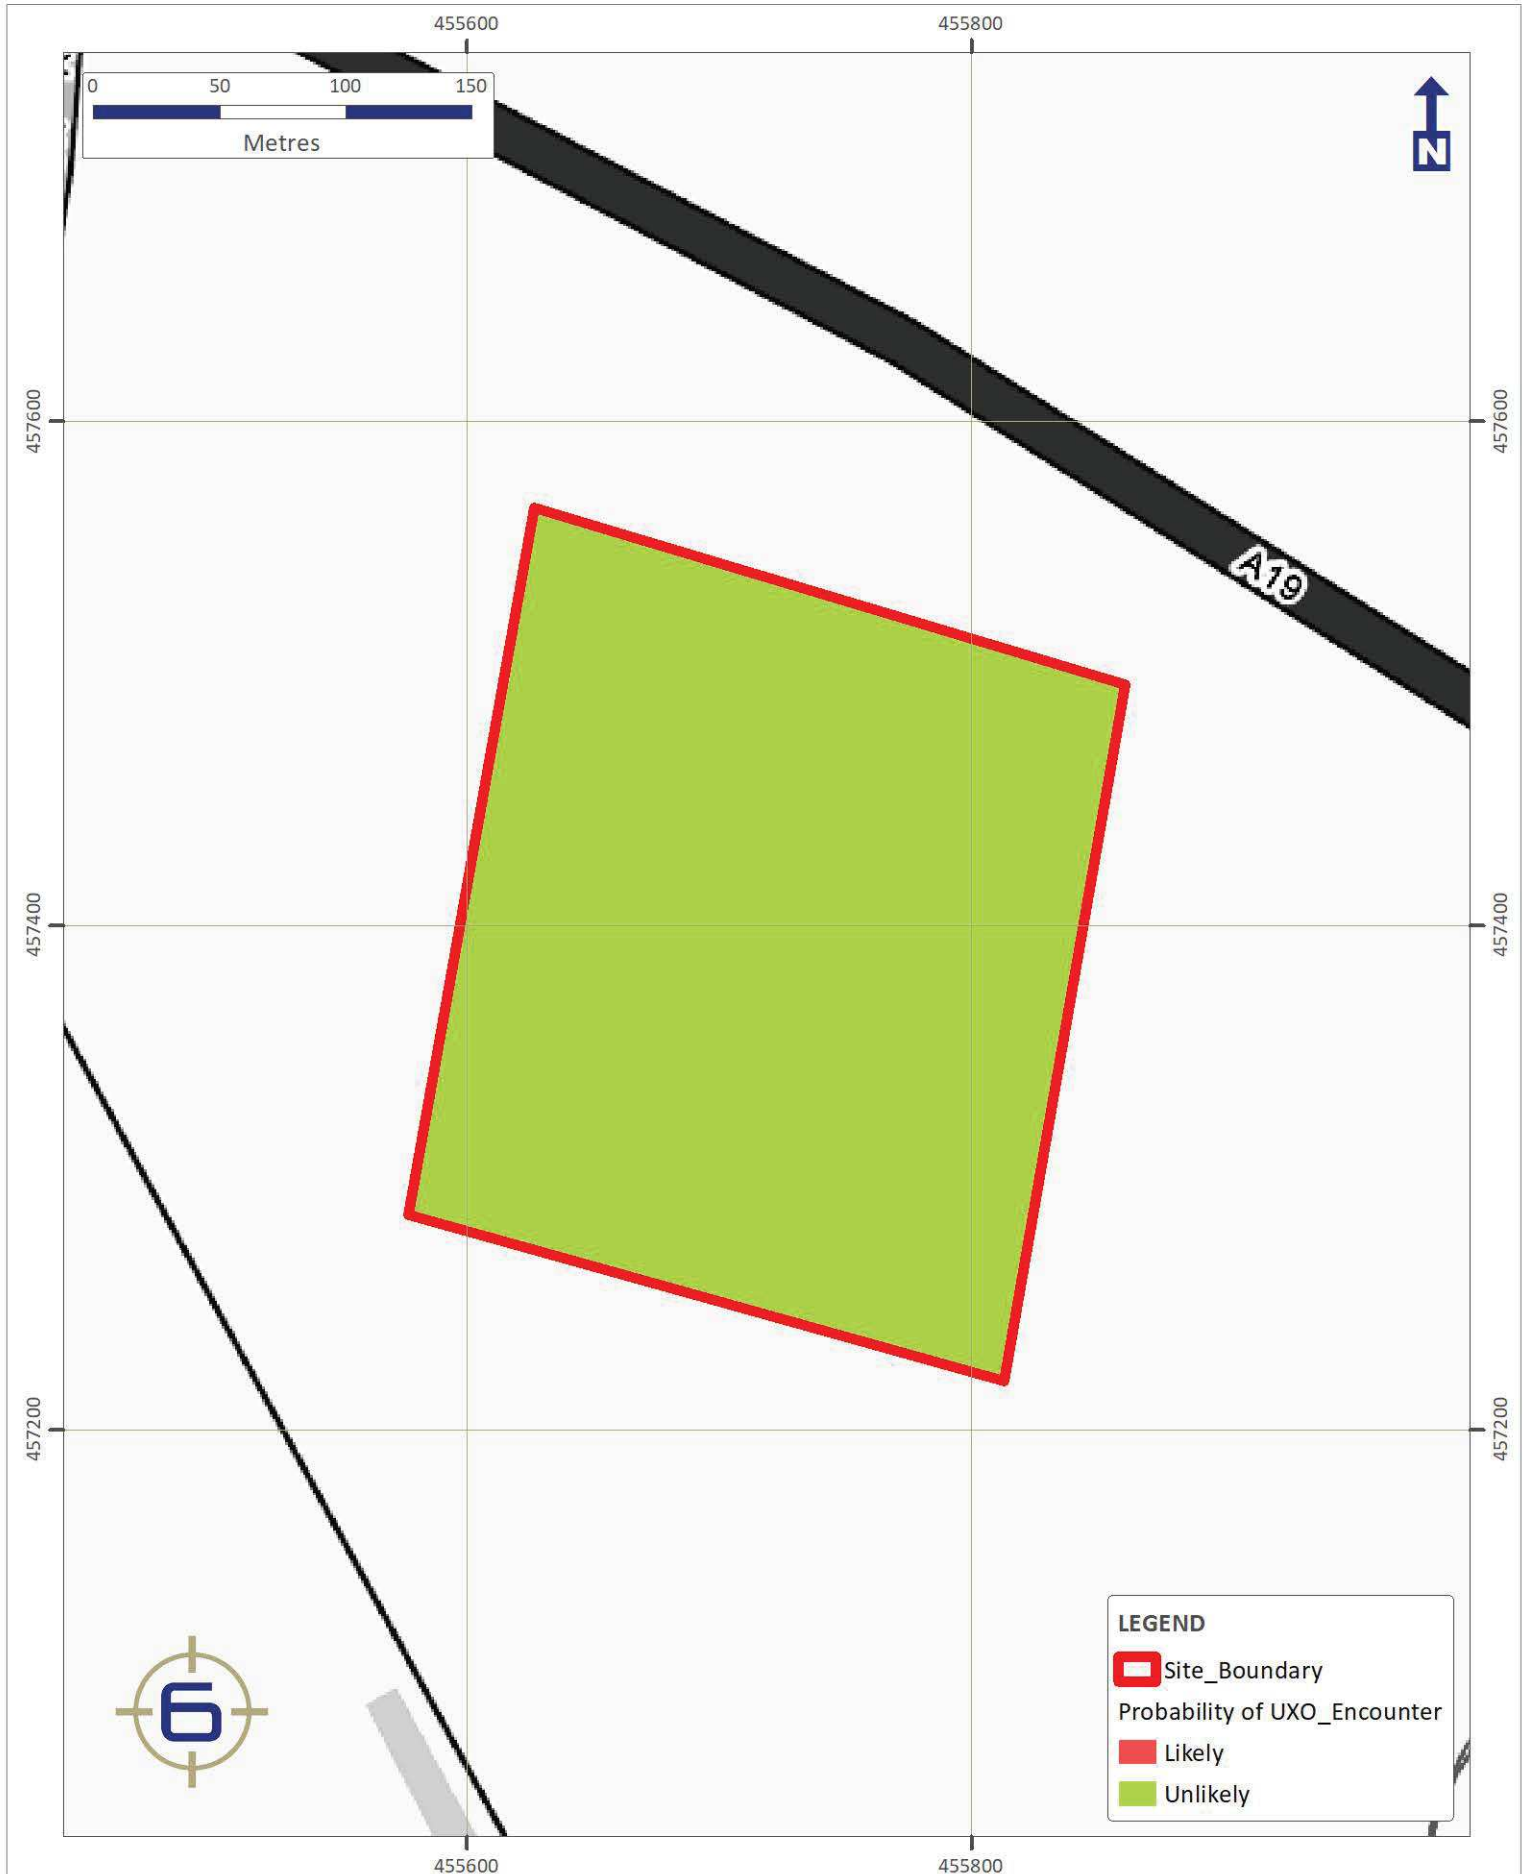
Probability of UXO Encounter

The potential for a UXO hazard to occur, and more specifically, the potential for unexploded WWI and WWII ordnance to exist at this site is assessed as being **UNLIKELY** (*Figure 2*).

In accordance with *CIRIA C681* Chapter 5 on managing UXO risks, *6 Alpha* concludes that **NO FURTHER ACTION** is required to address the UXO risk at this Study Site. Should you have any queries, please contact *Envirocheck*.

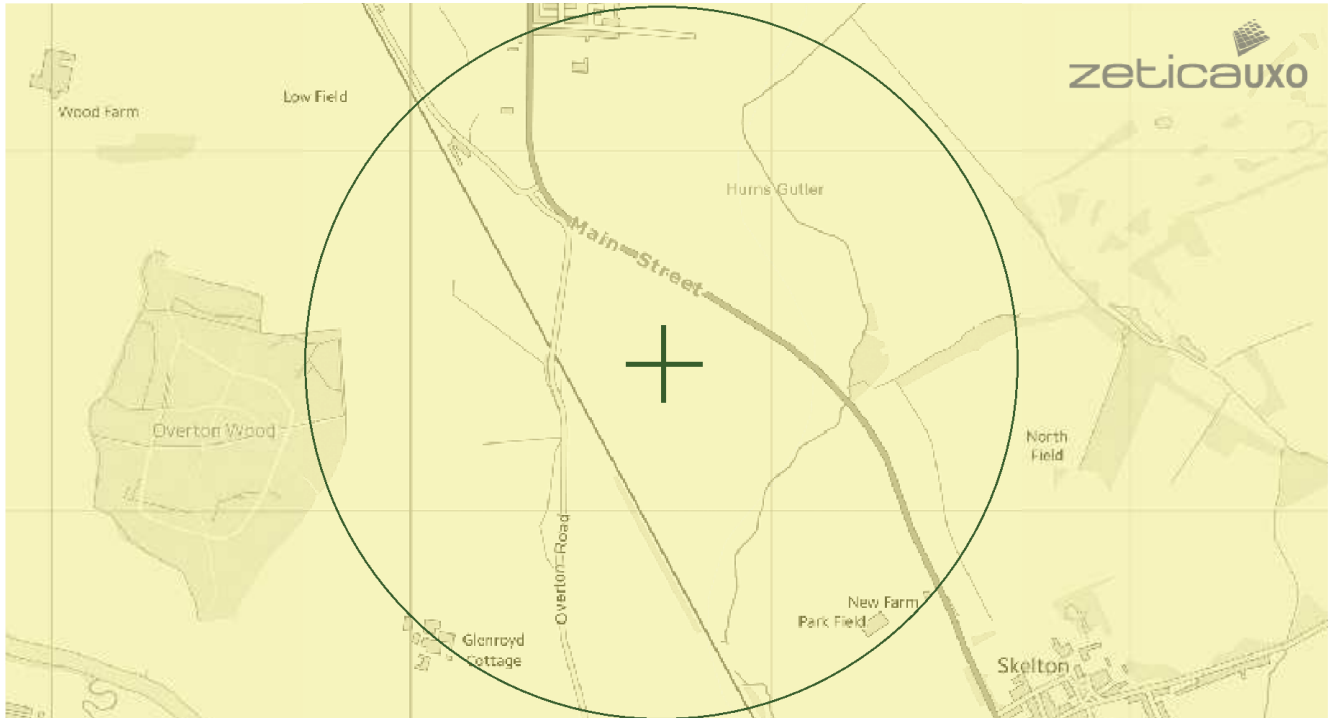
UNEXPLODED BOMB RISK MAP

The map indicates the potential for Unexploded Bombs (UXB) to be present as a result of World War Two (WWII) bombing.

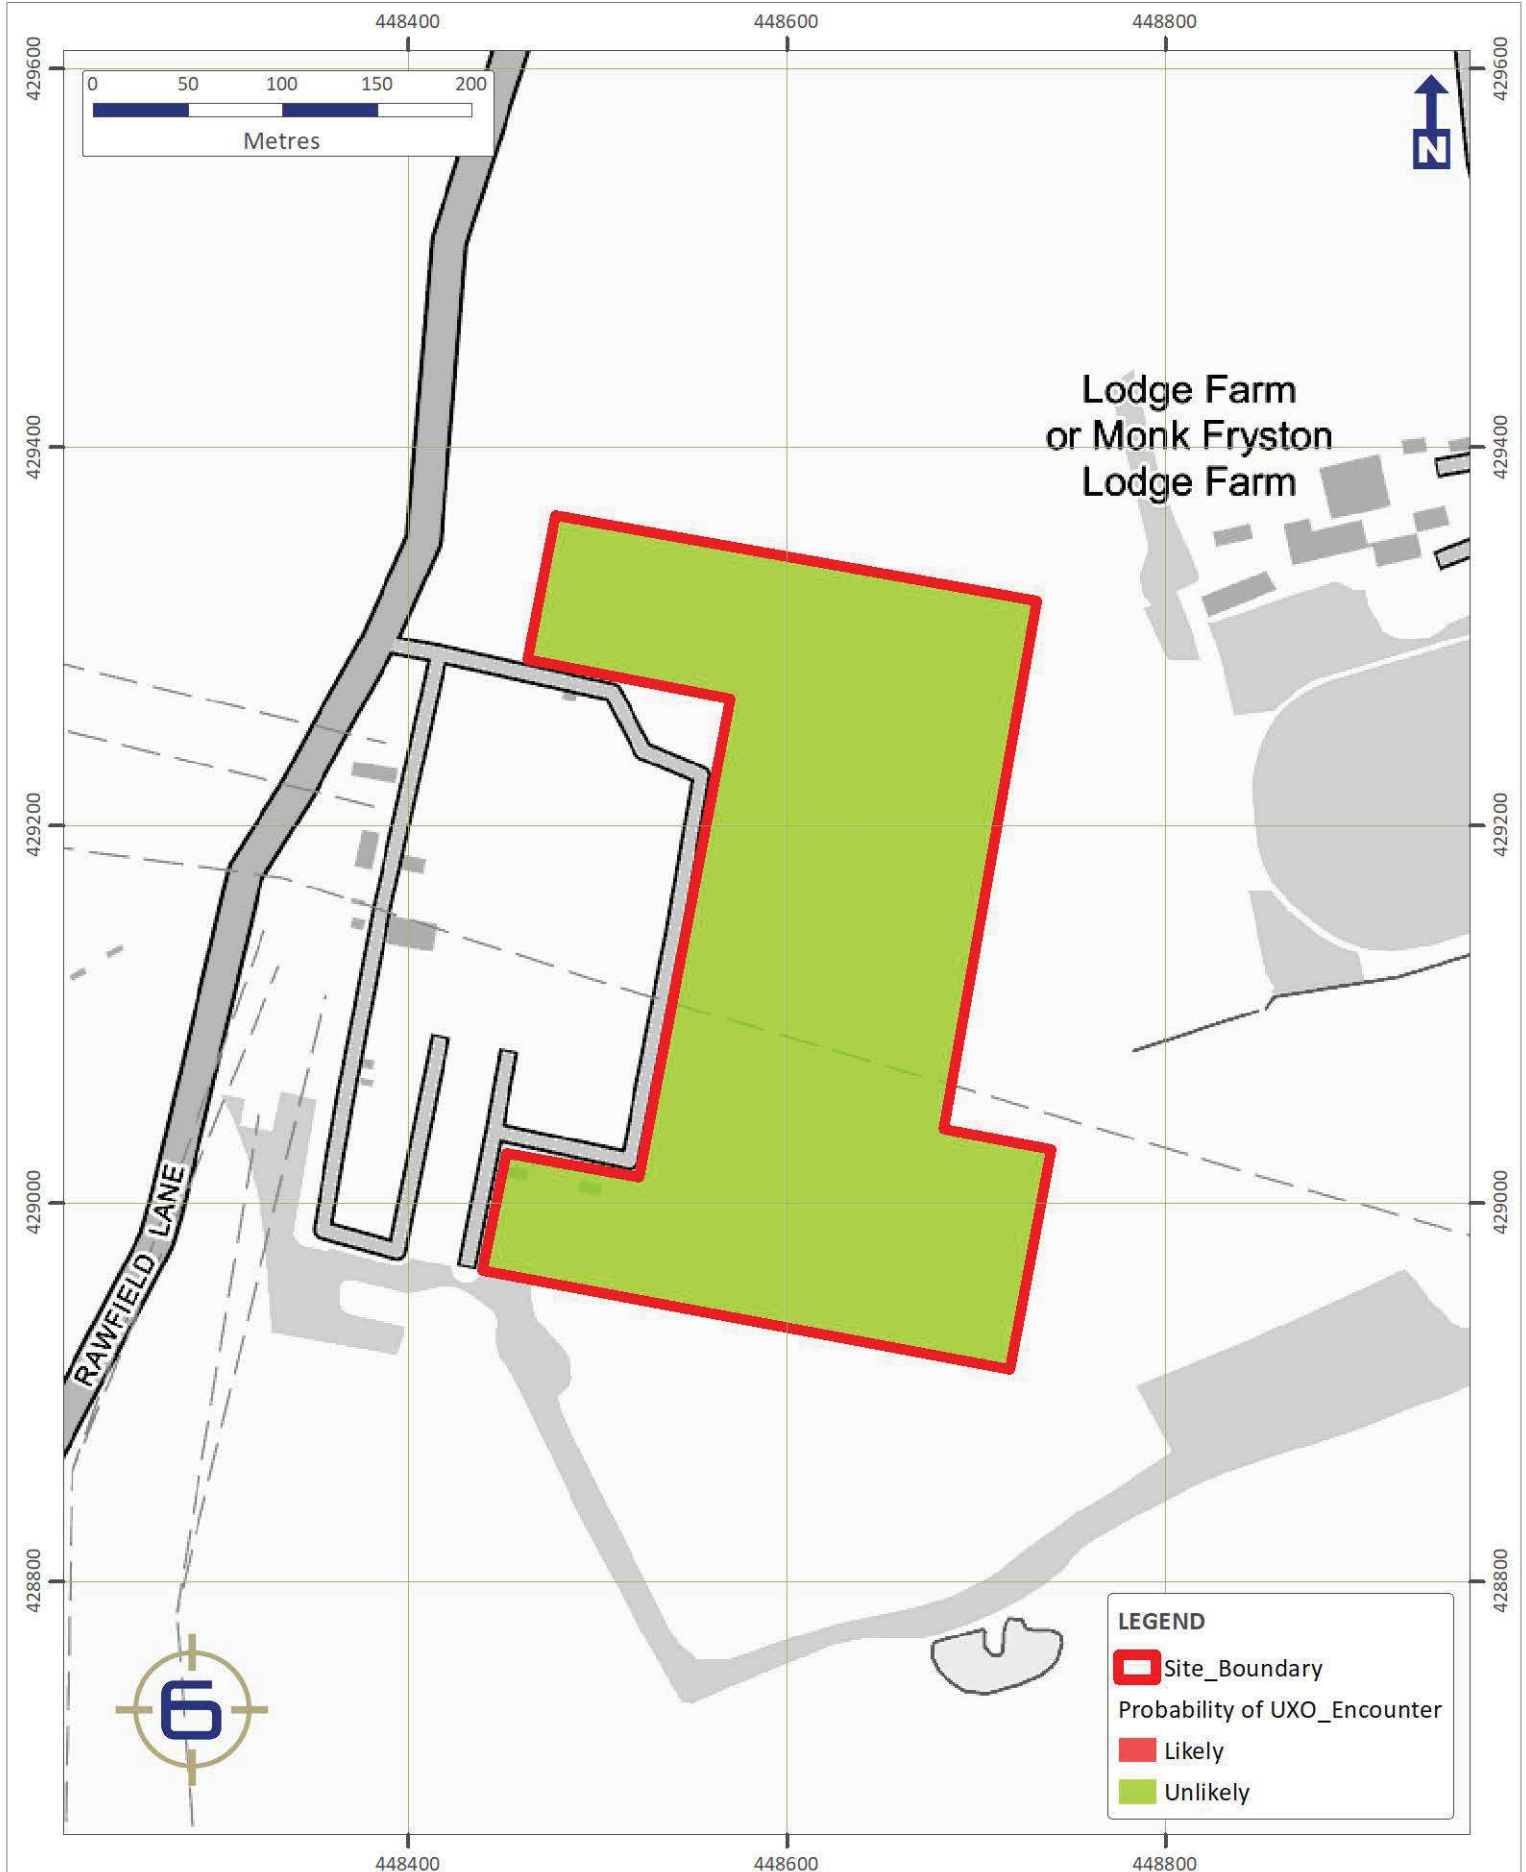
Probability of UXO Encounter

The potential for a UXO hazard to occur, and more specifically, the potential for unexploded WWI and WWII ordnance to exist at this site is assessed as being **UNLIKELY** (*Figure 2*).

In accordance with *CIRIA C681 Chapter 5 on managing UXO risks, 6 Alpha* concludes that **NO FURTHER ACTION** is required to address the UXO risk at this Study Site. Should you have any queries, please contact *Envirocheck*.

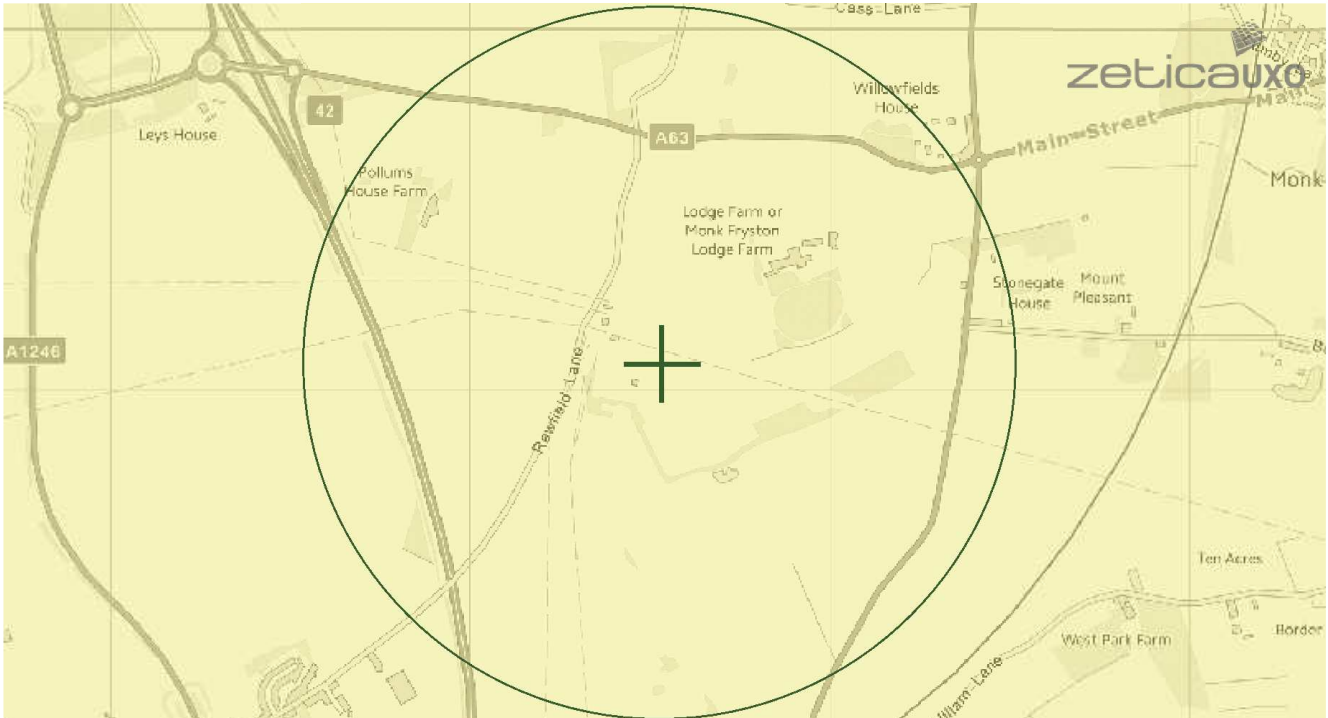
UNEXPLODED BOMB RISK MAP

The map indicates the potential for Unexploded Bombs (UXB) to be present as a result of World War Two (WWII) bombing.
