Re-opener Report

Bespoke: Tower Steelwork and Foundations
(NGET) – ET Special Condition 3.33

Date: 27 July 2022

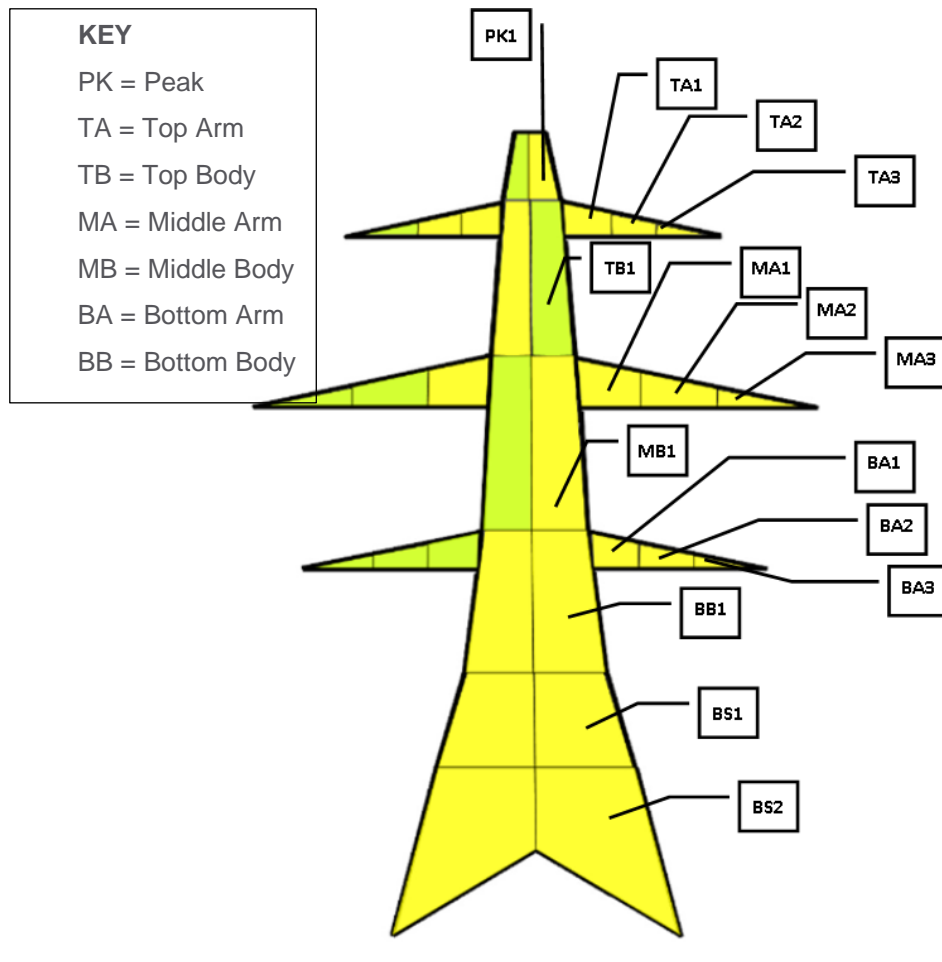
Figure 5.2: Schematic of overhead line tower broken down into zones for steelwork assessment

For HDCA, each tower is split into 30 assessment zones (15 zones per tower side) as per Figure 5.2 below. Each zone is visually assessed using high-definition photographic images, captured by helicopters, and assigned the worst steelwork grade seen within that zone.

Where a significant number of corroded secondary members are present along with the critical Grade 5 or 6 members within a section of OHL tower, it may warrant a full section replacement (see figure 5.2). Although this would involve a larger tonnage of steel, and require crane access to site, it may also significantly reduce the time taken to carry out the work, which would in turn reduce the costs associated with labour, overheads, and system outages. CBA 'B' compares these two options, and the outcome is that in this case, it would be beneficial to replace the entire **xx** earthwire peaks (section PK1 and equivalent PK2 on figure 5.2) containing significant numbers of corroded bars.

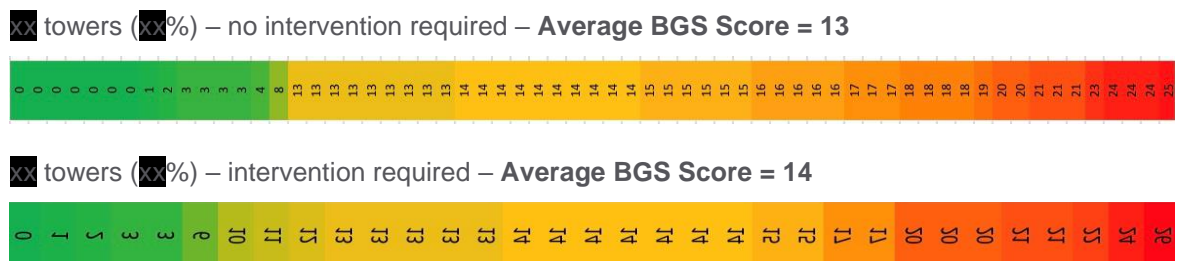
Figure 6.7: Comparison of BGS-based scoring

We found the BGS-based risk factors did not provide a reliable method of identifying vulnerable towers, with the distribution of scores for 'no intervention' vs. 'intervention required' being very similar to each other, as can be seen in figure 6.7 and Table 6.4 below.

We have reviewed the line schedules for the 4VK route and found almost 100% of this route has standard concrete foundations and have concluded there will be little value in completing investigations on this route. Accordingly, we propose to complete a further (xxxxx) foundation investigations ((xxxx) each on the ZBC and ZBD routes, which will be delivered as part of the respective RIIO-2 conductor schemes).
