# **Investment Decision Pack**

## **A9.13 – Through-wall & floor bushing**

As a part of the NGET Draft Business Plan Submission

**Engineering Justification Paper;  
Non-Load Related  
Through-Wall & Floor Bushings**

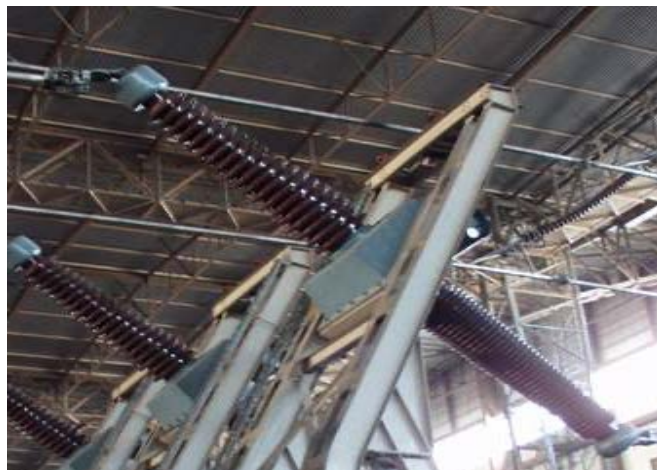
Figure 1 shows an example of a through wall bushing:

Figure 1 – Photograph of a 400kV through wall bushing

Through wall/floor bushings provide a means of safely passing high voltage busbar connections through solid surfaces such as the external or internal walls of substation buildings. In some cases, they also incorporate the measurement functionality of instrument transformers adding to their criticality for operation & protection of the transmission network. They are distinct from transformer bushings, GIS line end bushings or oil circuit breaker bushings which are not addressed in this paper.

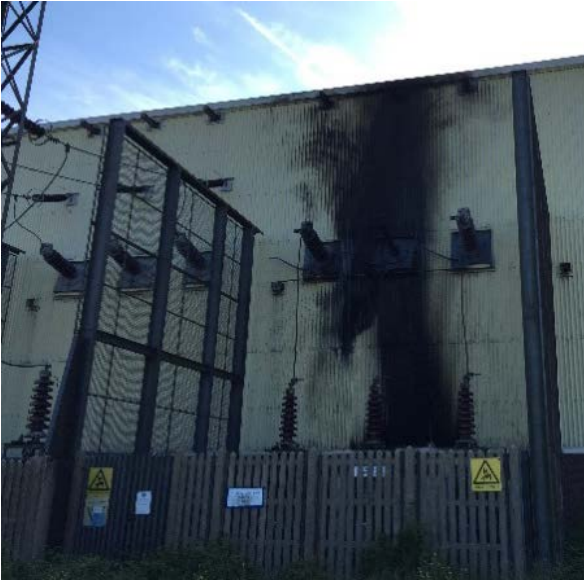
Figure 2a - External burning & carbonisation of substation wall

Failures of through wall/floor bushing failures are typically of an explosive (catastrophic) nature resulting in porcelain dispersal across the substation with the associated potential for safety risks to personnel and consequential damage to adjacent assets. NGET has experienced such failures and applies Risk Management Hazard Zones (RMHZ) around equipment discovered to be in poor asset health to control access into the equipment and to keep people safe should a failure occur. The photographs forming Figure 2 below demonstrate the various aspects of such a catastrophic failure of a 132kV oil impregnated paper through wall bushing.

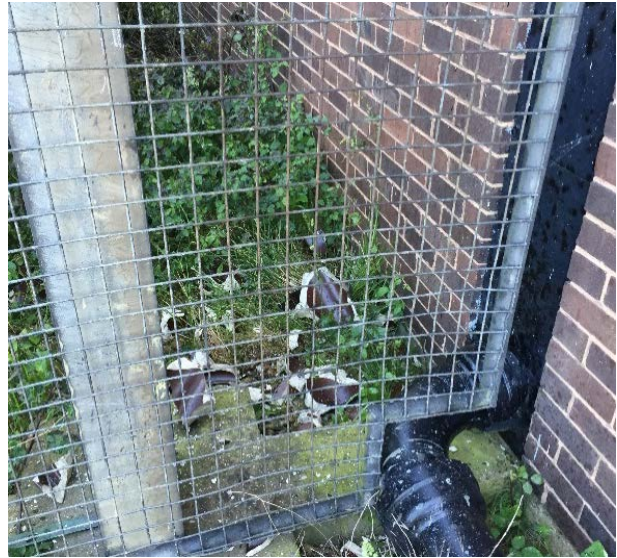
Figure 2b - Porcelain fragments ejected up to 30m

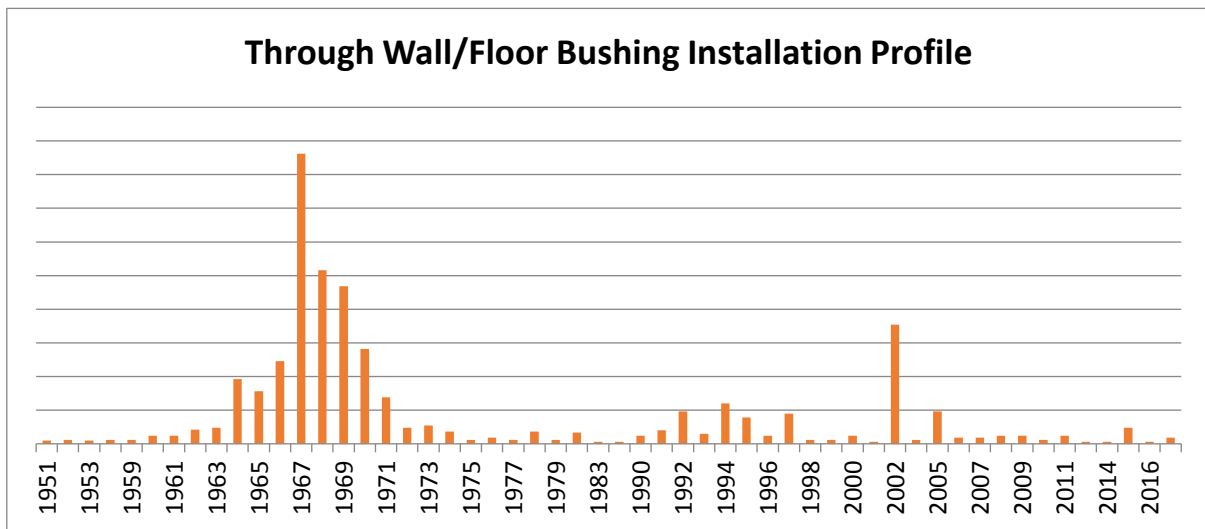
The construction of indoor AIS substations was a common practice at 132kV up to, and including, 400kV from the mid-1960's until the early 1970's. There are [REDACTED] through wall/floor bushings on the transmission network with over half of the units installed at 132kV or below. Figure 5 shows the asset profile of through wall/floor bushings based on year installed.

Figure 5 - Through wall/floor bushing installation profile

On a limited scale, we have explored more innovative online condition monitoring technology. This has allowed the refinement of replacement planning based on the condition which has helped to better inform the T2 plan as it has provided an insight on asset health. As can be seen from the installation profile in figure 5, the volume of bushings which require replacement in T3 could be significantly larger than T2. In our condition monitoring justification, we include an investment in enhanced monitoring for bushings, which will allow us to find innovative methods to manage the risk on bushings for the T3 period.
