Appendix B Geo-environmental and Geotechnical Desk Study Report

Scotland England Green Link 1 - English Onshore Scheme

Geo-Environmental and Geotechnical Desk Study
Land at Hawthorn Pit

National Grid Electricity Transmission

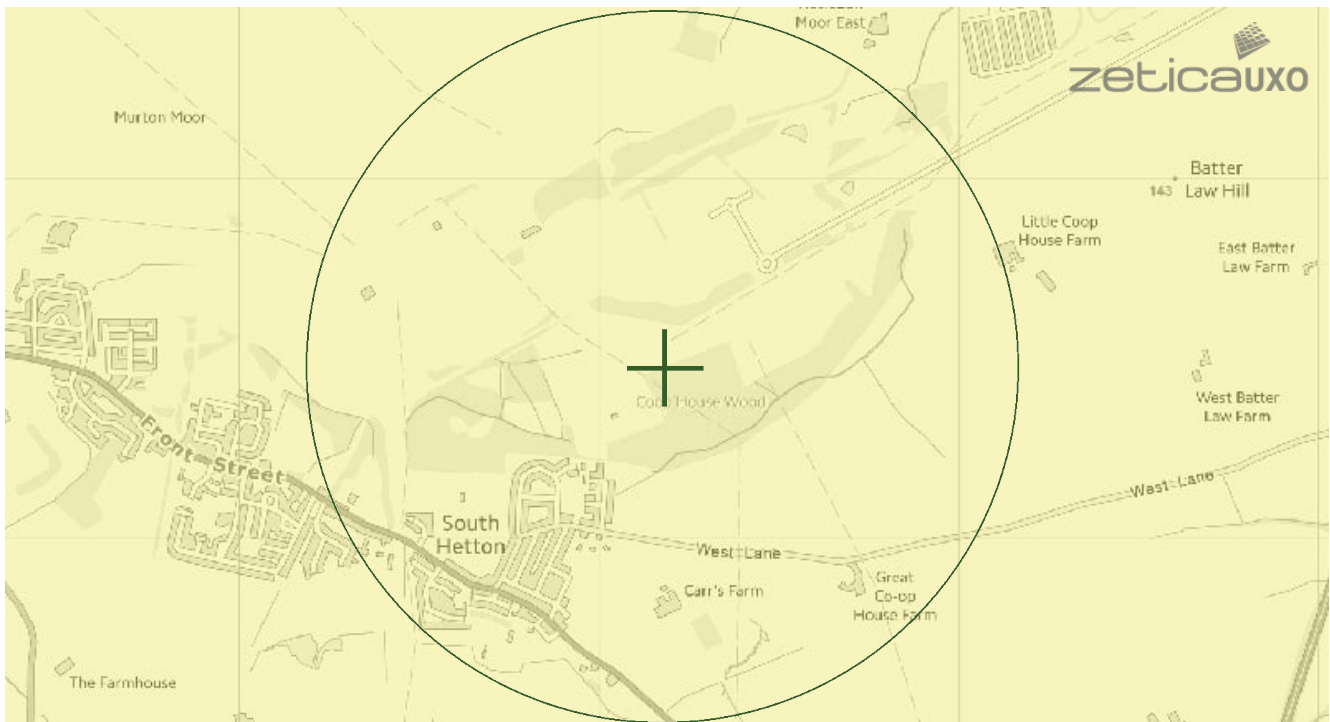
SITE LOCATION

- High:** Areas indicated as having a bombing density of 50 bombs per 1000acre or higher.
- Moderate:** Areas indicated as having a bombing density of 15 to 49 bombs per 1000acre.
- Low:** Areas indicated as having 15 bombs per 1000acre or less.
