Yorkshire GREEN Project

Environmental Impact Assessment

Volume three: Appendix 7A Historic Environment Desk Based
Assessment

October 2021

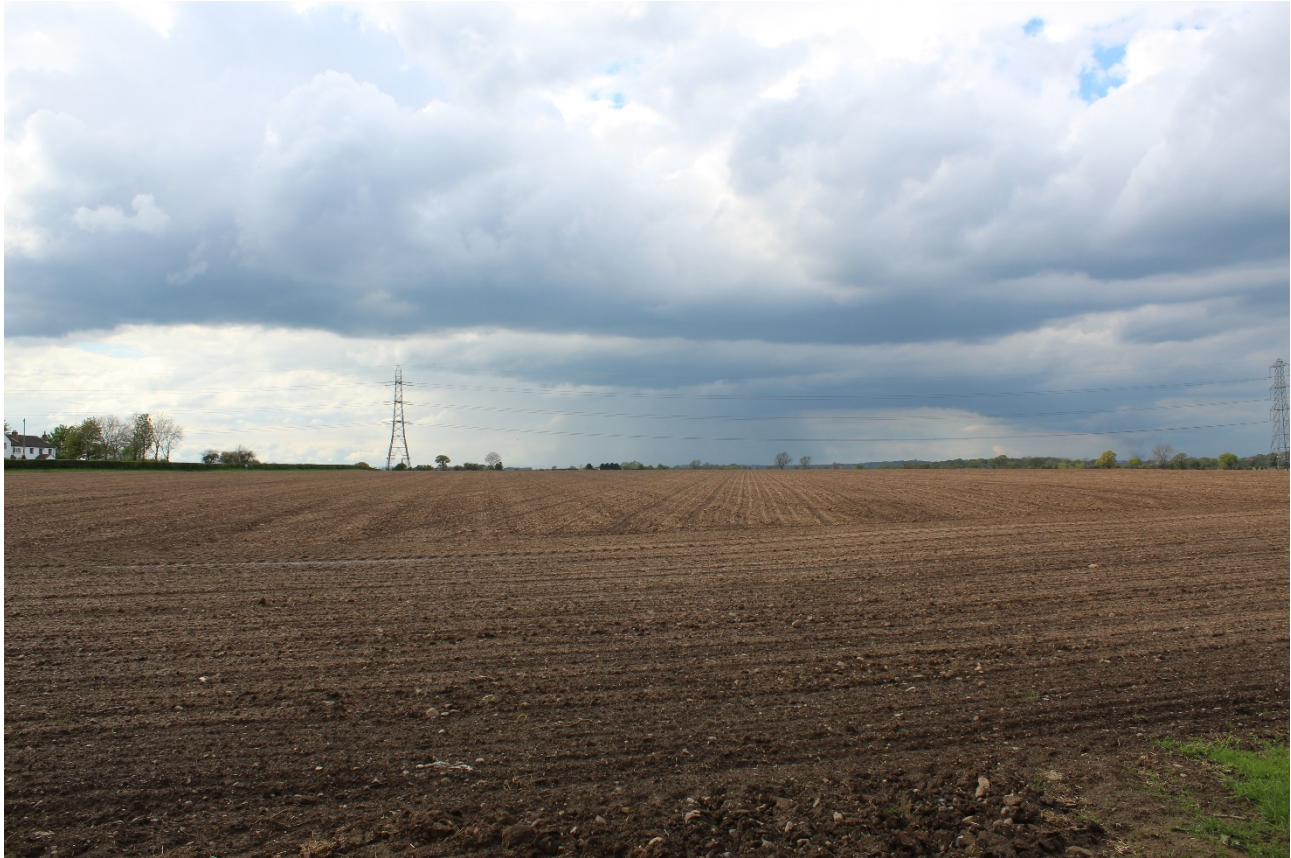
Image 1 - Site of the Battle of Marston Moor looking west towards the existing 275kV Poppleton to Monk Fryston (XC/XCP) overhead line

3.2.147 There is high potential in the north of the HLC area for the presence of artefacts and possibly burials associated with the Battle of Marston Moor. There is medium potential for buried structural remains relating to previous occupational phases in the post-medieval and medieval periods within open spaces around existing properties. There is low potential for buried early medieval settlement remains within open areas, as has been found elsewhere through recent investigations and research⁴³. The potential for pre-early medieval settlement remains is also low due to a lack of recorded evidence within the HLC area.

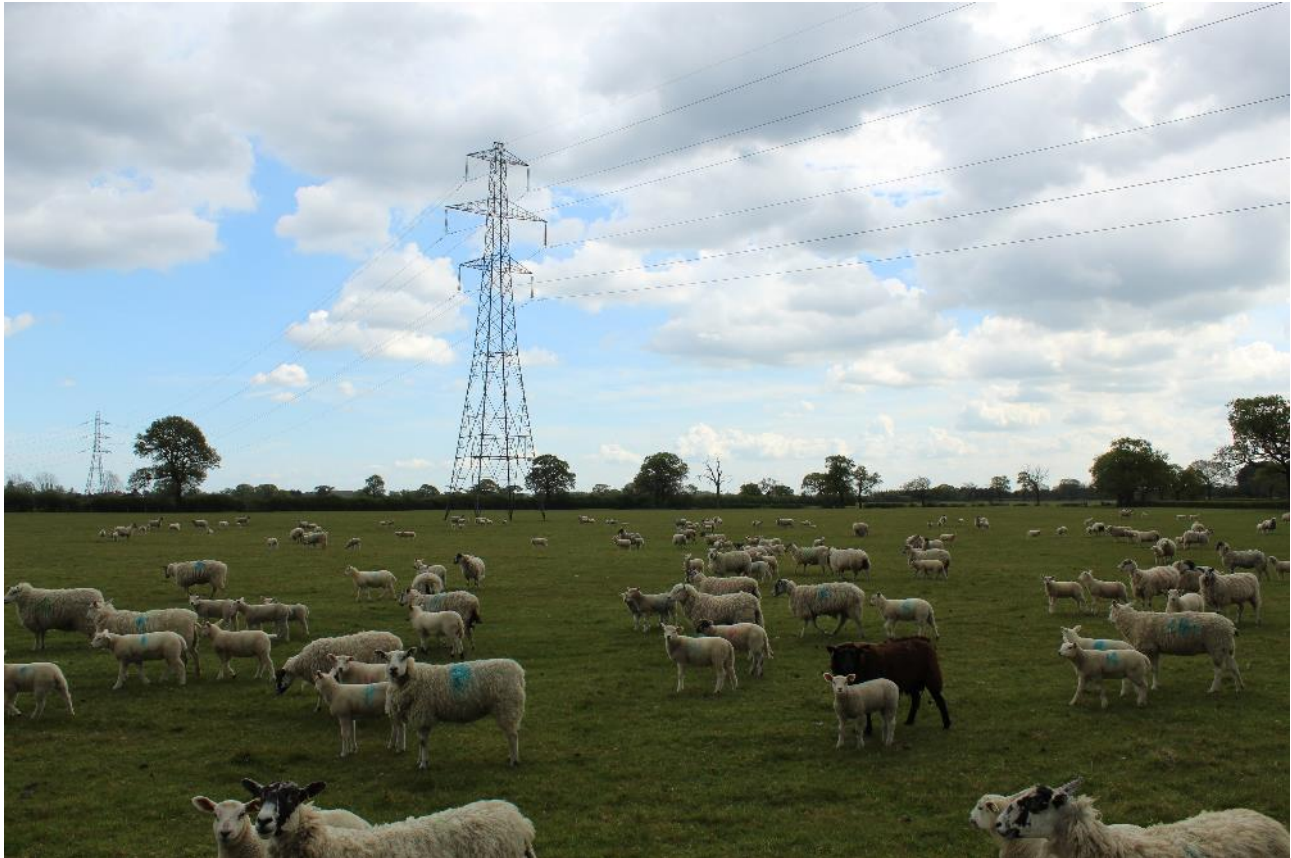
Image 2 - Site of cropmark around pylon XCP 008
